The Sahara® Leak Location System Commissioning New Pipelines

Case study: J Murphy and Sons - Farmoor to Blunsdon Duplication Main, 800mm GRP

Case study: Thames Water International - Puerto Rico North Coast Super Aqueduct

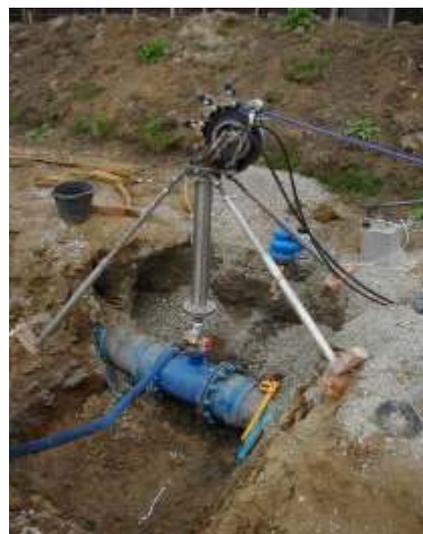
Testing a newly laid PVC main

The Sahara system can be used to locate leaks already detected by a pressure test or alternatively, in the case of plastic pipes and MDPE in particular, it can be used to check the integrity of the pipeline before embarking on a lengthy pressure test.

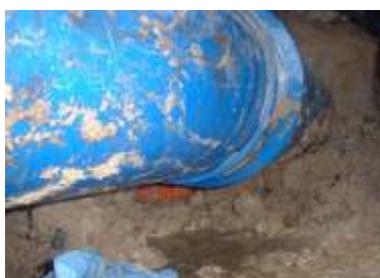
Leaking joint on a new PVC main

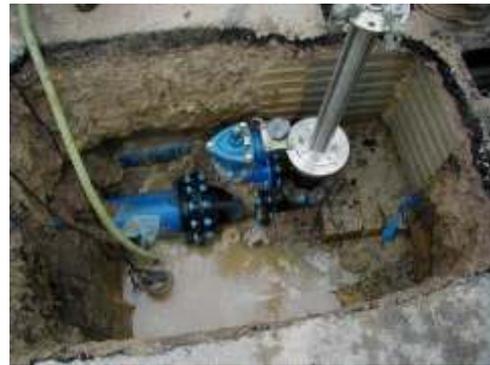
Inserting into hydrant fitting

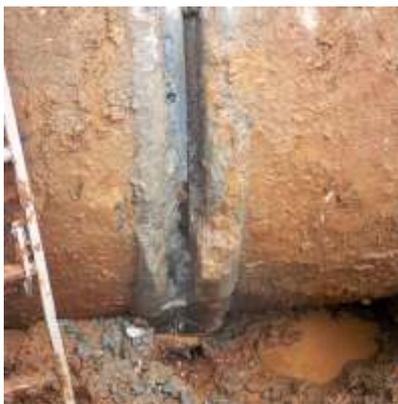
Leaking 6' PCCP main

During the final construction phase of a 50 mile long 6' (1800mm) diameter pipeline, leakage from the line was identified. The leakage was sufficient to cause failure of the commissioning tests and looked set to cause delay; there was also concern that the resulting ground moisture could lead to corrosion of the pipeline reinforcement. The static tests that identified the leakage were able to narrow down the suspected leaking sections of pipeline – although this still left 25km requiring inspection. Conventional methods of leak location tried first to find the leaks were unable to detect the leaks.

Thames Water International contracted the Sahara system to be used to locate the leaks. All the identified sections were successfully surveyed and five leaks pin-pointed. Leak magnitude varied at each location; the smallest leak located being just 0.001 l/s. Following the repairs, the pipeline was proved as leak-tight, passing all commissioning procedures.
